Manhole Inspection Summary

Manhole # S25G__003MH

Location Address: **1072 FAYETTE ST**

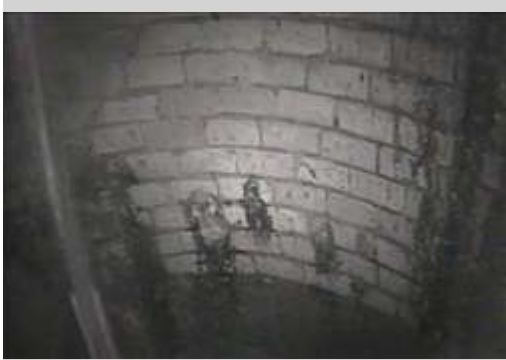
Defect 3

Infiltration: ☐ None ☐ Joint ☐ Cracks ☐ Mortar ☐ Roots ☒ **Wall**

BARREL INFILTRATION

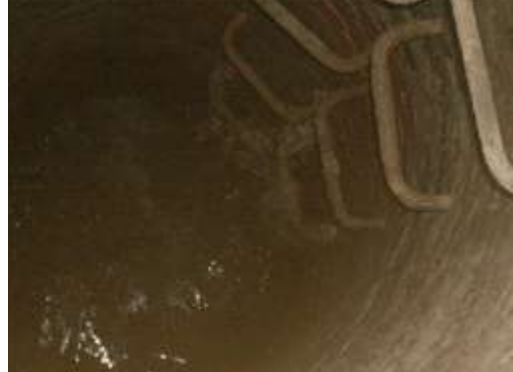
Defect 2

Count: **14** Missing: **0** ☒ **Corroded**

CORRODED STEPS

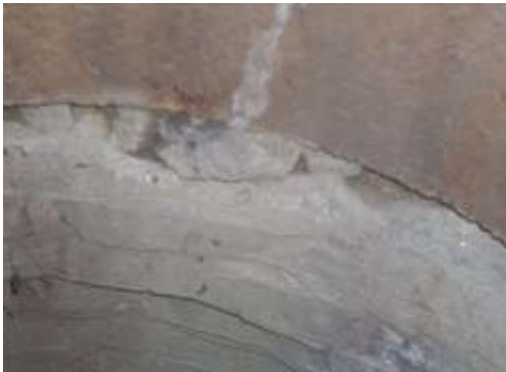
Defect 1

Condition: ☐ Sound ☐ Cracked ☐ Root Intrusion ☐ Loose Brick ☒ **Deteriorated**

DETERIORATION OF CHIMNEY

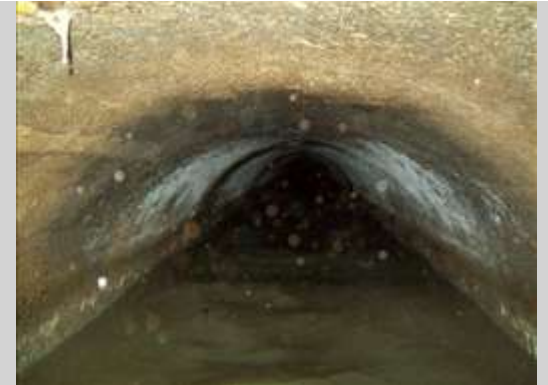
12 O'Clock Outflow

54 in. Circular Gravity Sewer
Pipe Out @ 12 O'Clock

Pipe Height: **55.2** (in.) Direct (Angled)
Pipe Material: **Concrete** ☐ Pipe Lined
Invert Depth: **22.61** (ft.) Flow Characteristics: **Fast**
Deposits: ☒ None ☐ Mud ☐ Sludge ☐ Debris ☐ Grease
Silt Depth: (in.) Deposits Extent:
Infiltration: **None** Pipe Seal Cond: **Sound**

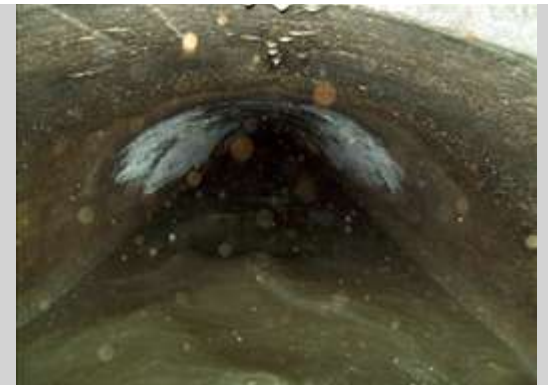
6 O'Clock Inflow

54 in. Circular Gravity Sewer
Pipe In @ 6 O'Clock

Pipe Height: **54** (in.) Direct (Angled)
Pipe Material: **Concrete** ☐ Pipe Lined
Invert Depth: **22.63** (ft.) Flow Characteristics: **Fast**
Deposits: ☒ None ☐ Mud ☐ Sludge ☐ Debris ☐ Grease
Silt Depth: (in.) Deposits Extent:
Infiltration: **None** Pipe Seal Cond: **Sound**

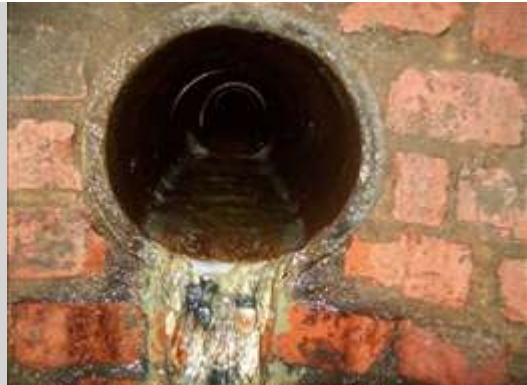
9 O'Clock Inflow

8 in. Circular Gravity Sewer

Pipe In @ 9 O'Clock

Pipe Height: **8.4** (in.) Direct (Angled)

Infiltration: **None** Pipe Seal Cond: **Sound**
